## **Minerals Inspection Report**

Mine Name: UDOT Beck Street Mine Status: Permit Number: M/011/0003 Active Paid Operator Name: Lakeview Rock Products, Inc 05/01/2013 Permit Fees: Inspection Date: \$374,100 Inspector(s): L. Heppler Inspection Time: 4:00 PM **Bond Amount:** Attendee(s): John Burggraf Weather: Sunny, Dry Bond Escalation: 08/18/2011 Inspection Purpose: Routine annual inspection Prior Inspection: 04/24/2010

Mine: M/011/0003 Inspected: 05/01/2013

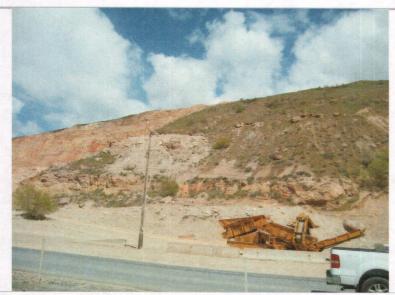
Overview of the site - looking east, from the bottom of the site

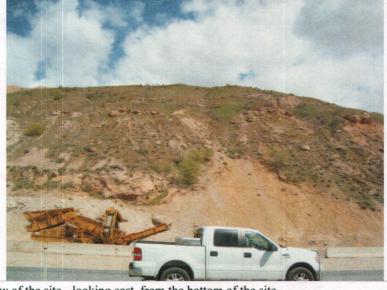
Overview of the site - looking east, from the bottom of the site

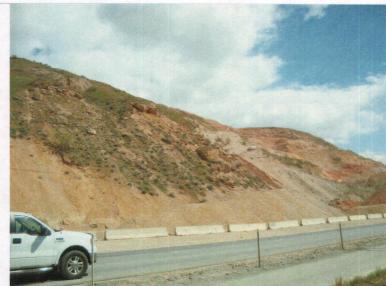
Overview of the site - looking east, from the bottom of the site

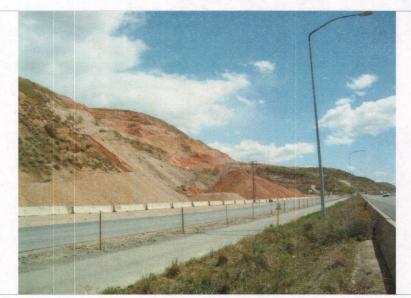
Overview of the site - looking east, from the bottom of the site
